# ENVIRONMENTAL ASSESSMENT WORKSHEET

**1. Project Title: Pioneer Trail Industrial Park**

**2. Proposer: Landspec Fund II, LLC**

**3. Responsible Governmental Unit: City of Corcoran**

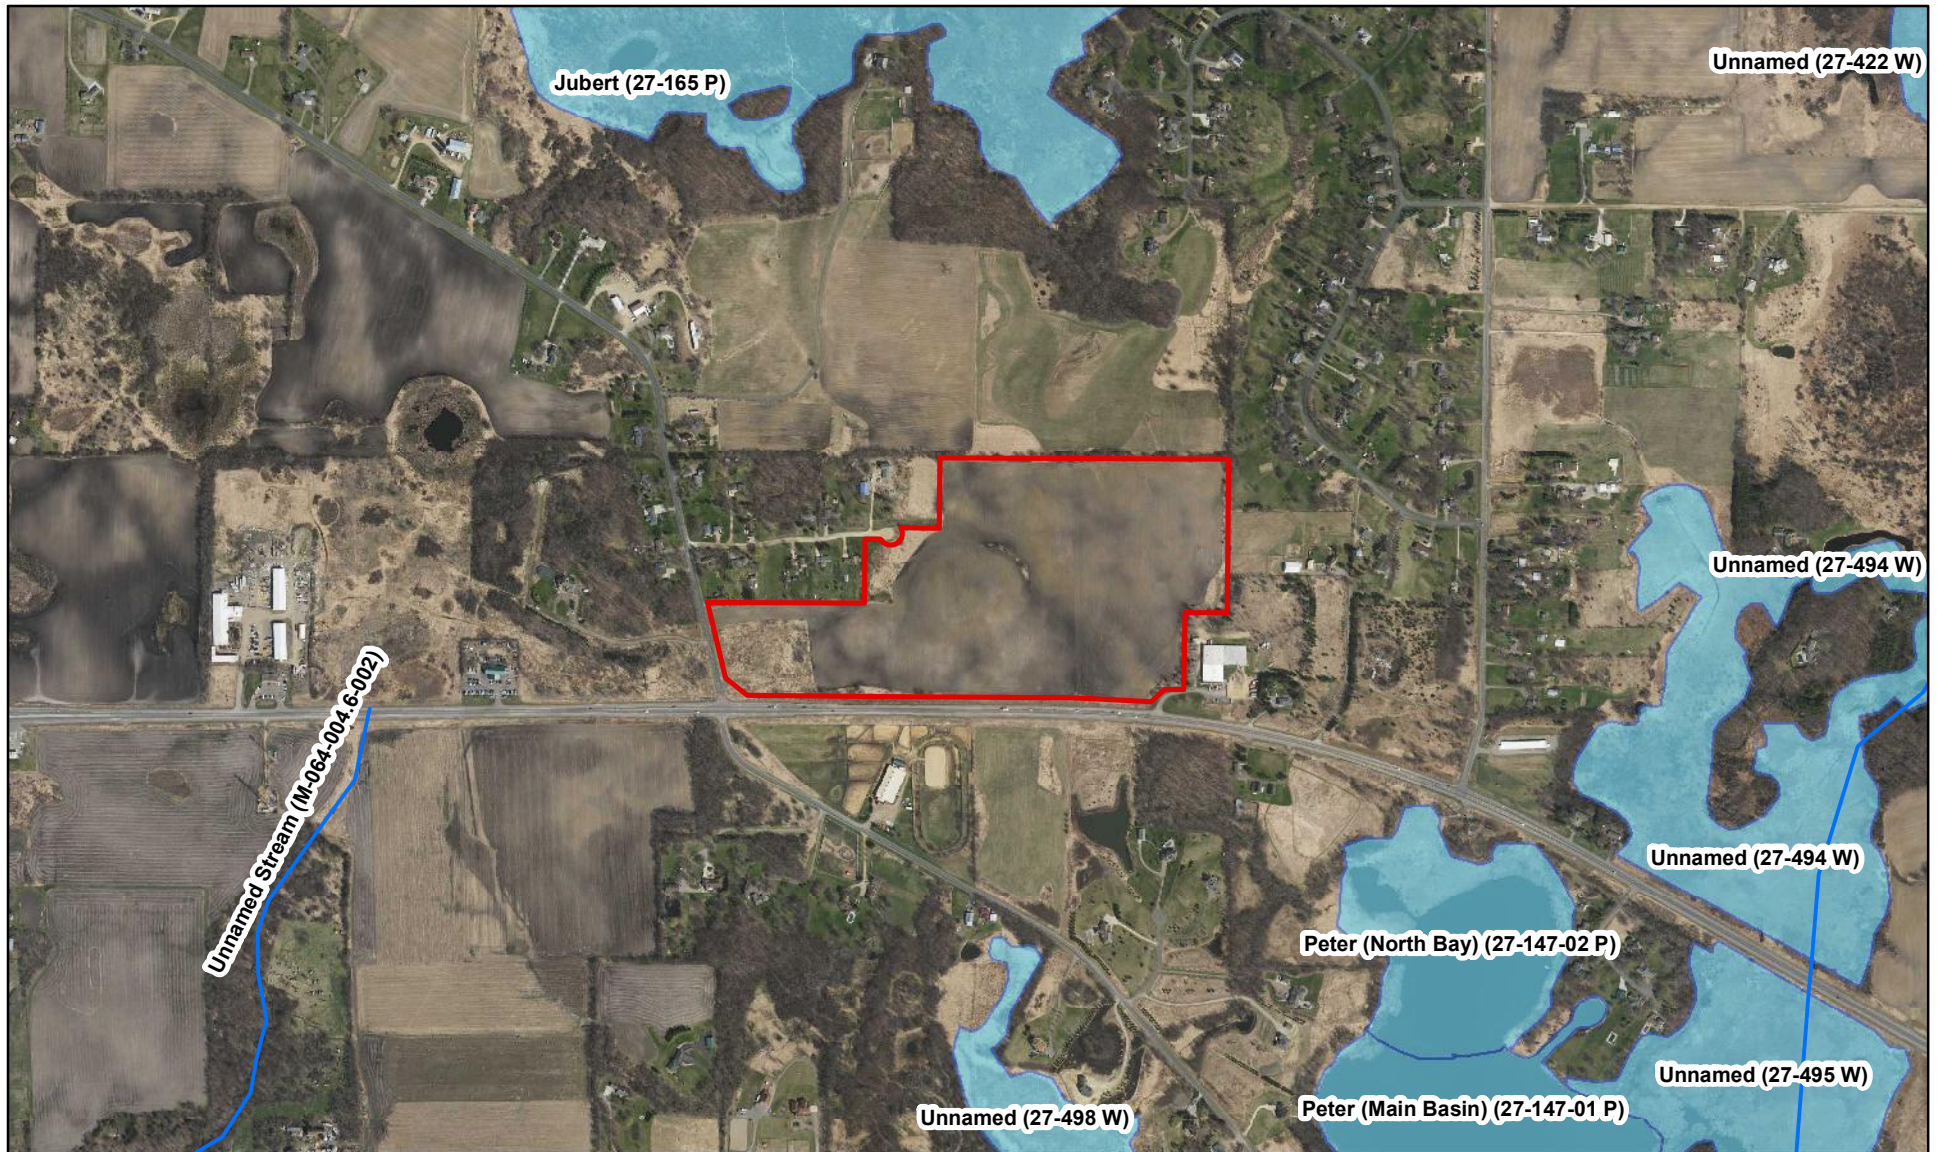
**Figure 5 - DNR Public Waters Inventory**

The [Minnesota DNR Public Waters Inventory](#) (Minnesota Department of Natural Resources 2015) did not show any DNR Public Waters, DNR Public Waterways or DNR Public Wetlands within 1000 feet of the site (**Figure 5**).

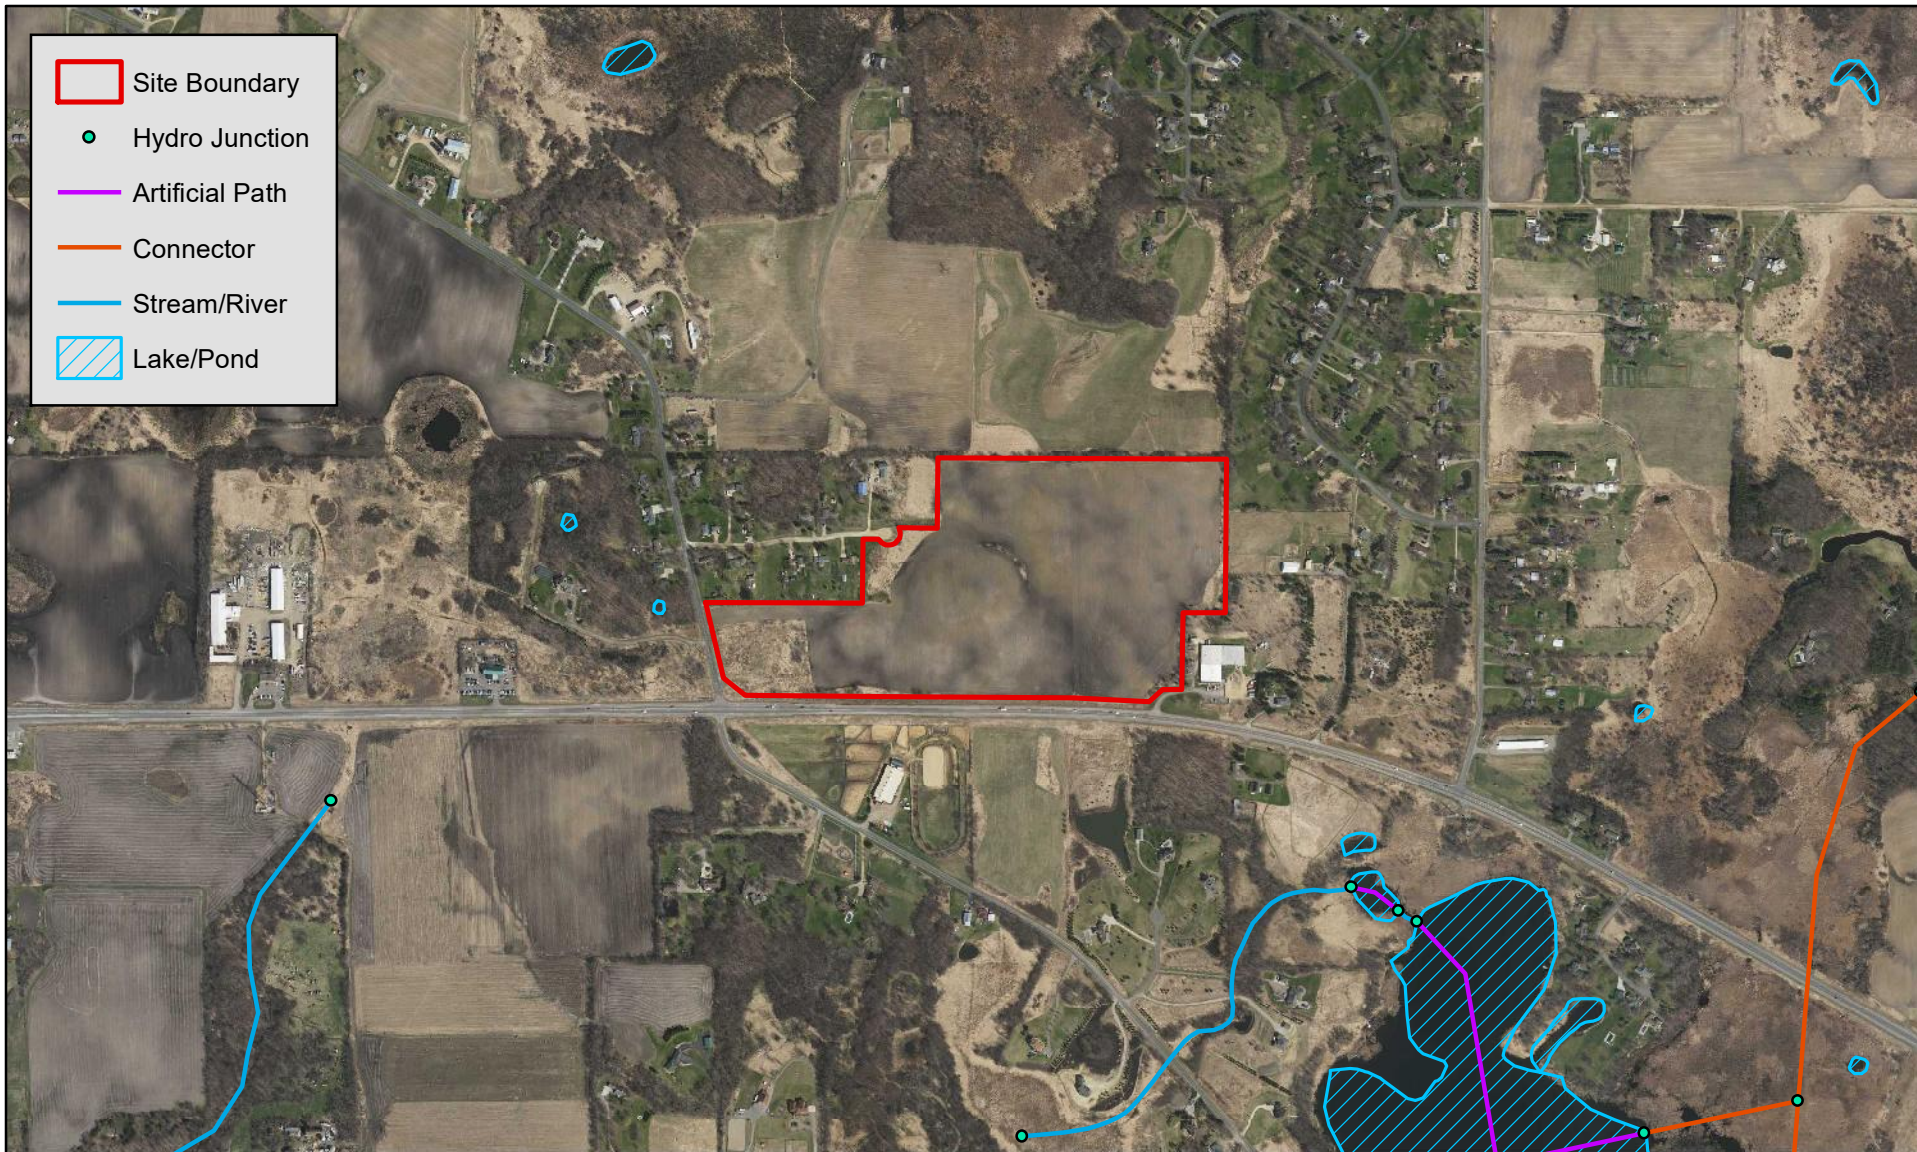
**Figure 6 - National Hydrography Dataset**

The [National Hydrography Dataset](#) (U.S. Geological Survey 2015) showed one Lake/Pond approximately 200 feet west of the site (**Figure 6**).

- Site Boundary
- Hydro Junction
- Artificial Path
- Connector
- Stream/River
- Lake/Pond

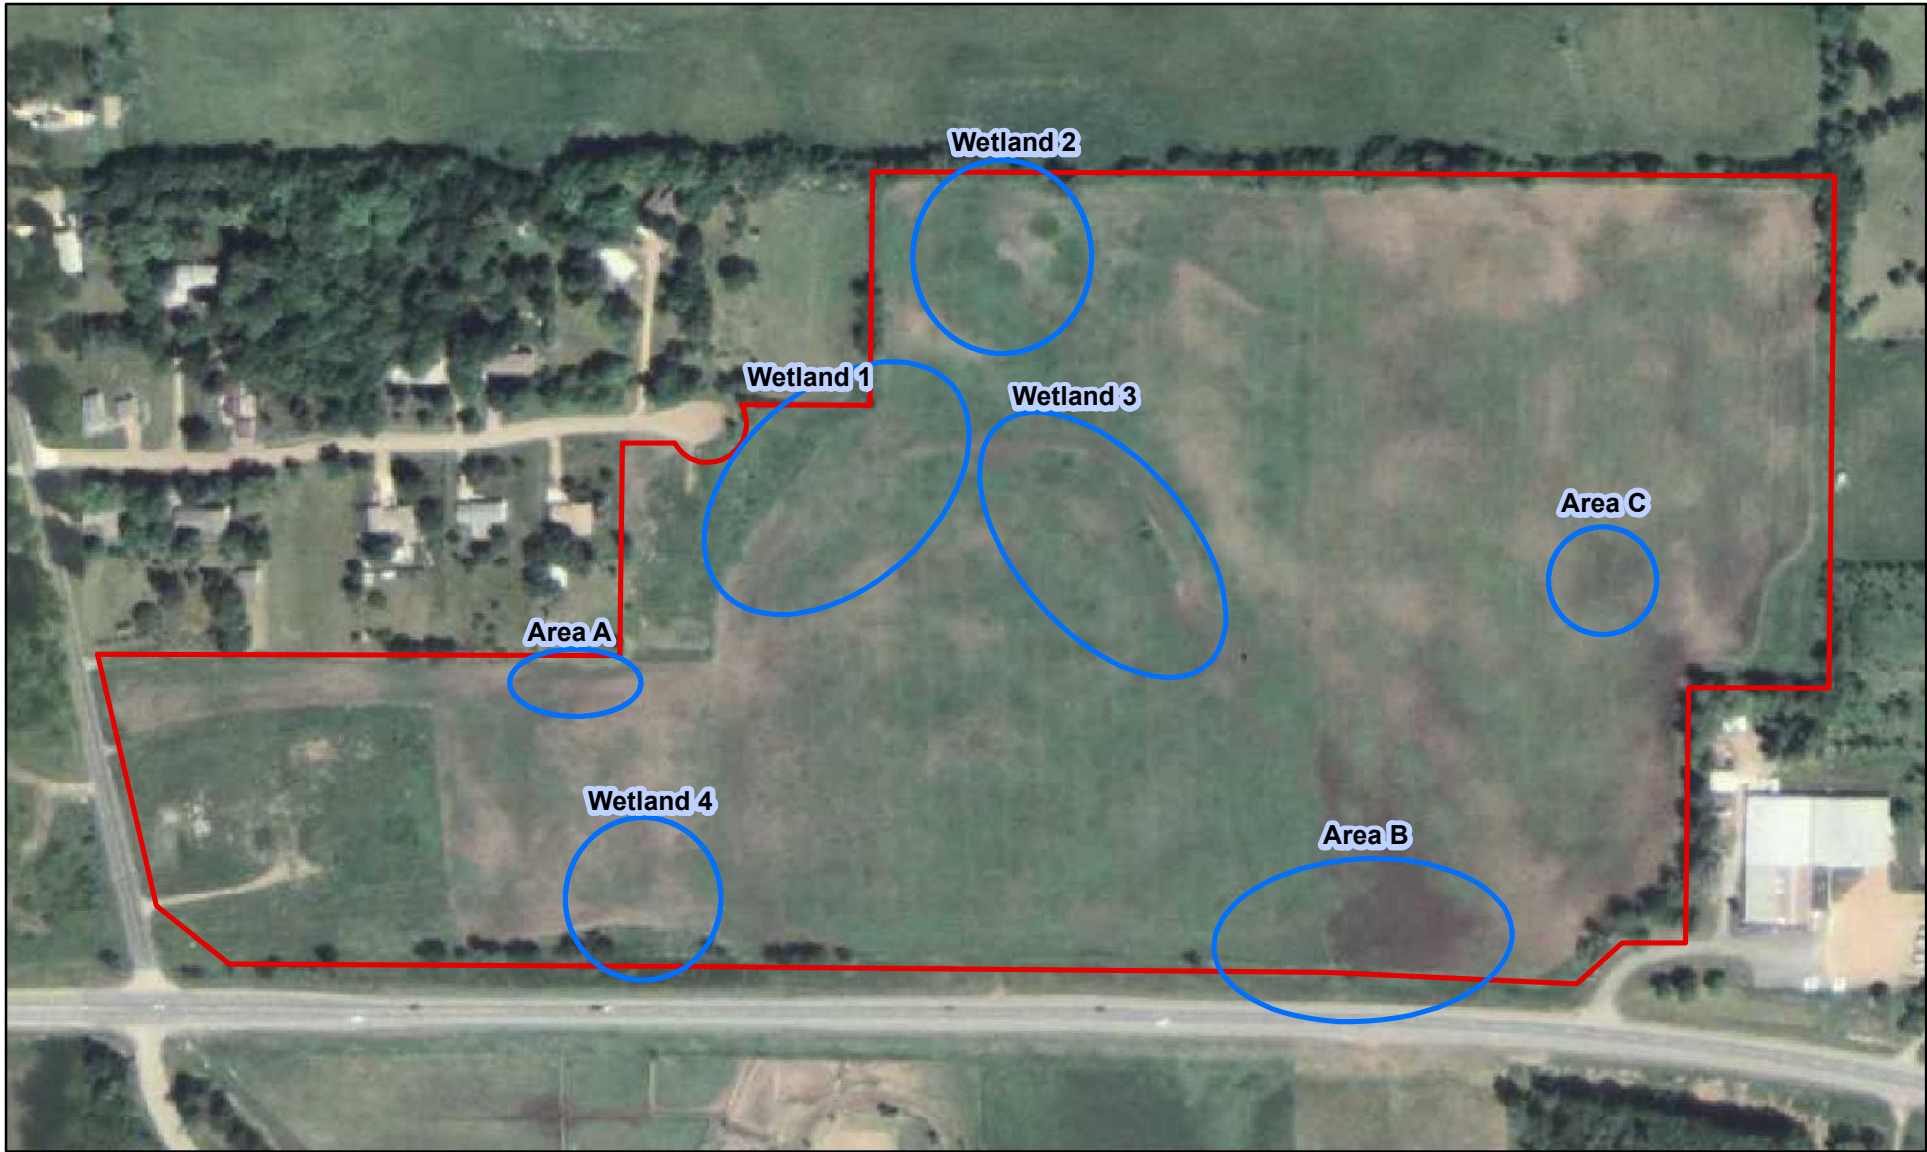
**Offsite Hydrology Assessment Year (2009 FSA Photo: Dry Year)**

Signatures at locations of potential wetlands on aerial photographs were interpreted and classified using seven codes (**Table 2**). Wetland hydrology was assumed to be present within areas exhibiting wetland signatures in more than 50% of years with normal climatic conditions based on antecedent precipitation.

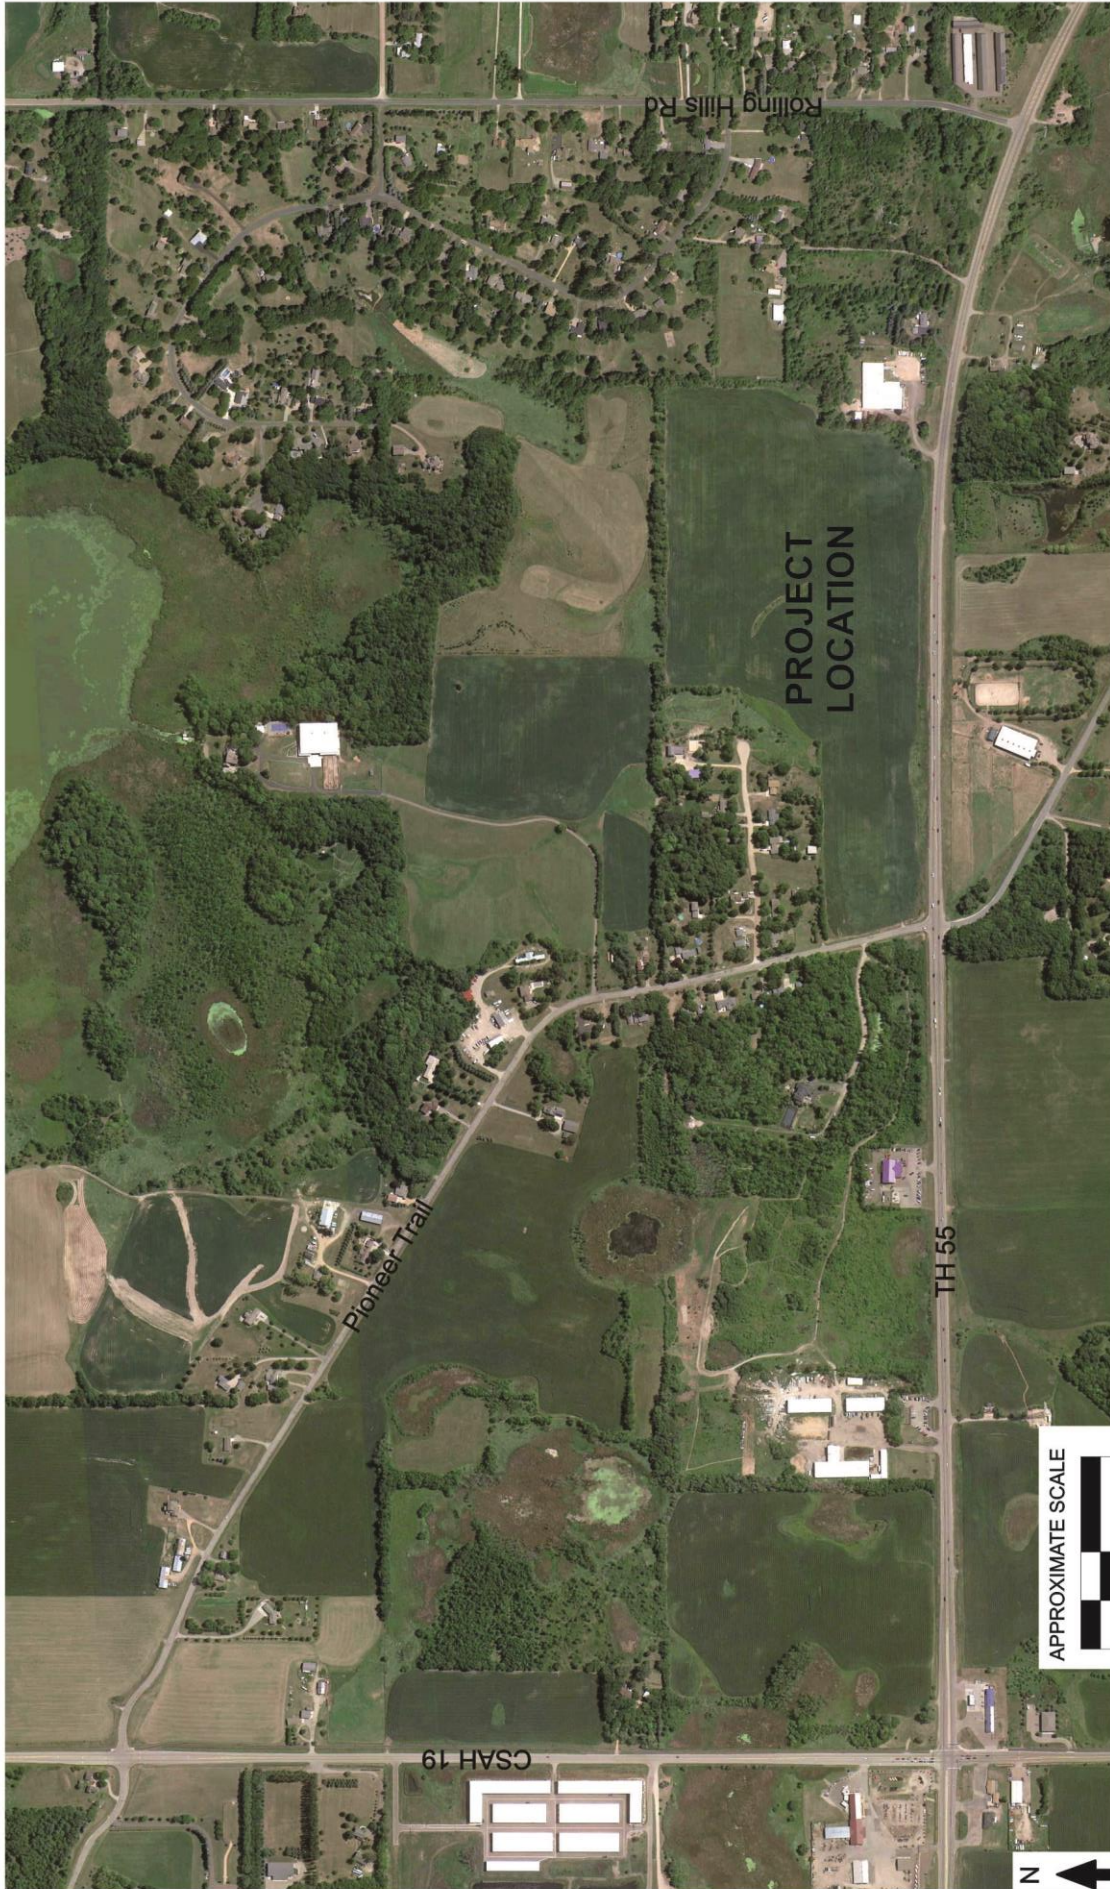
**FIGURE 3**  
**EXISTING CONDITIONS**

Weekday traffic volume data was recorded at the existing intersections in January, 2022. Existing traffic volume data is presented later in this report.

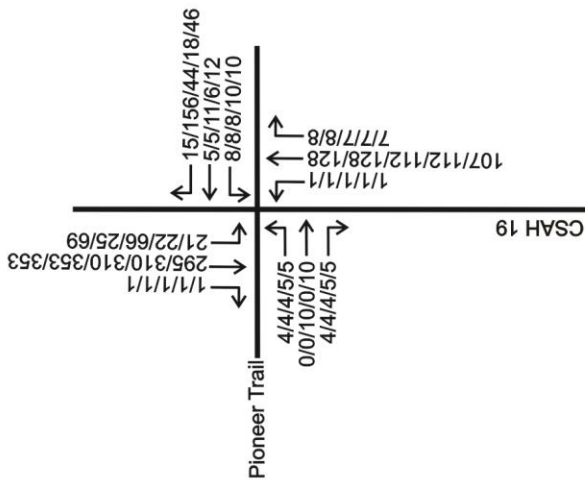
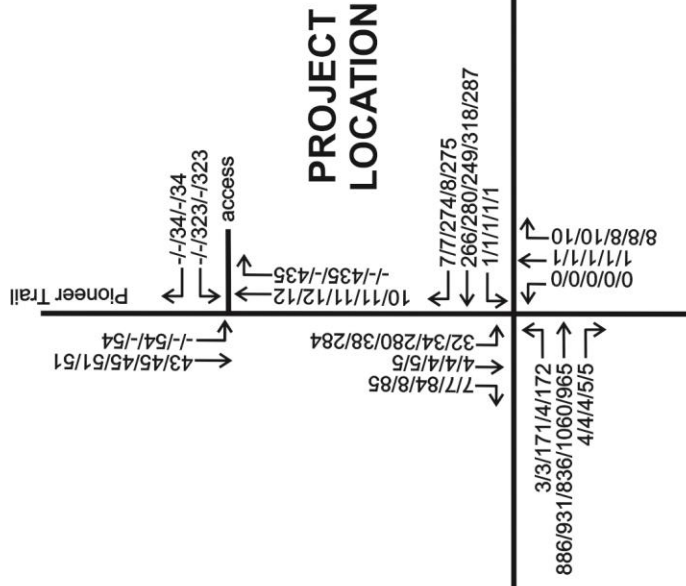
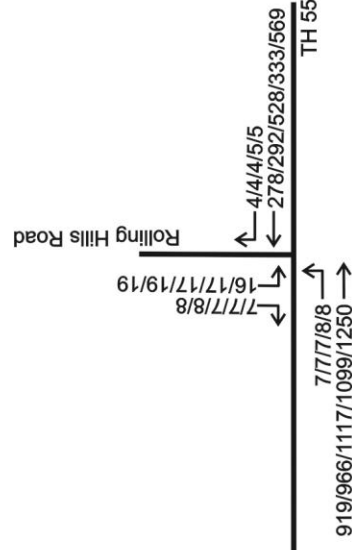
**FIGURE 4**  
**WEEKDAY AM PEAK HOUR**  
**TRAFFIC VOLUMES**

Development trips from Table 4-1 were assigned to the surrounding roadway network using the preceding trip distribution percentages. Traffic volumes were established for all the forecasting scenarios described earlier during the weekday a.m. and p.m. peak hours. The resultant peak hour volumes are shown in **Figures 4 and 5**.

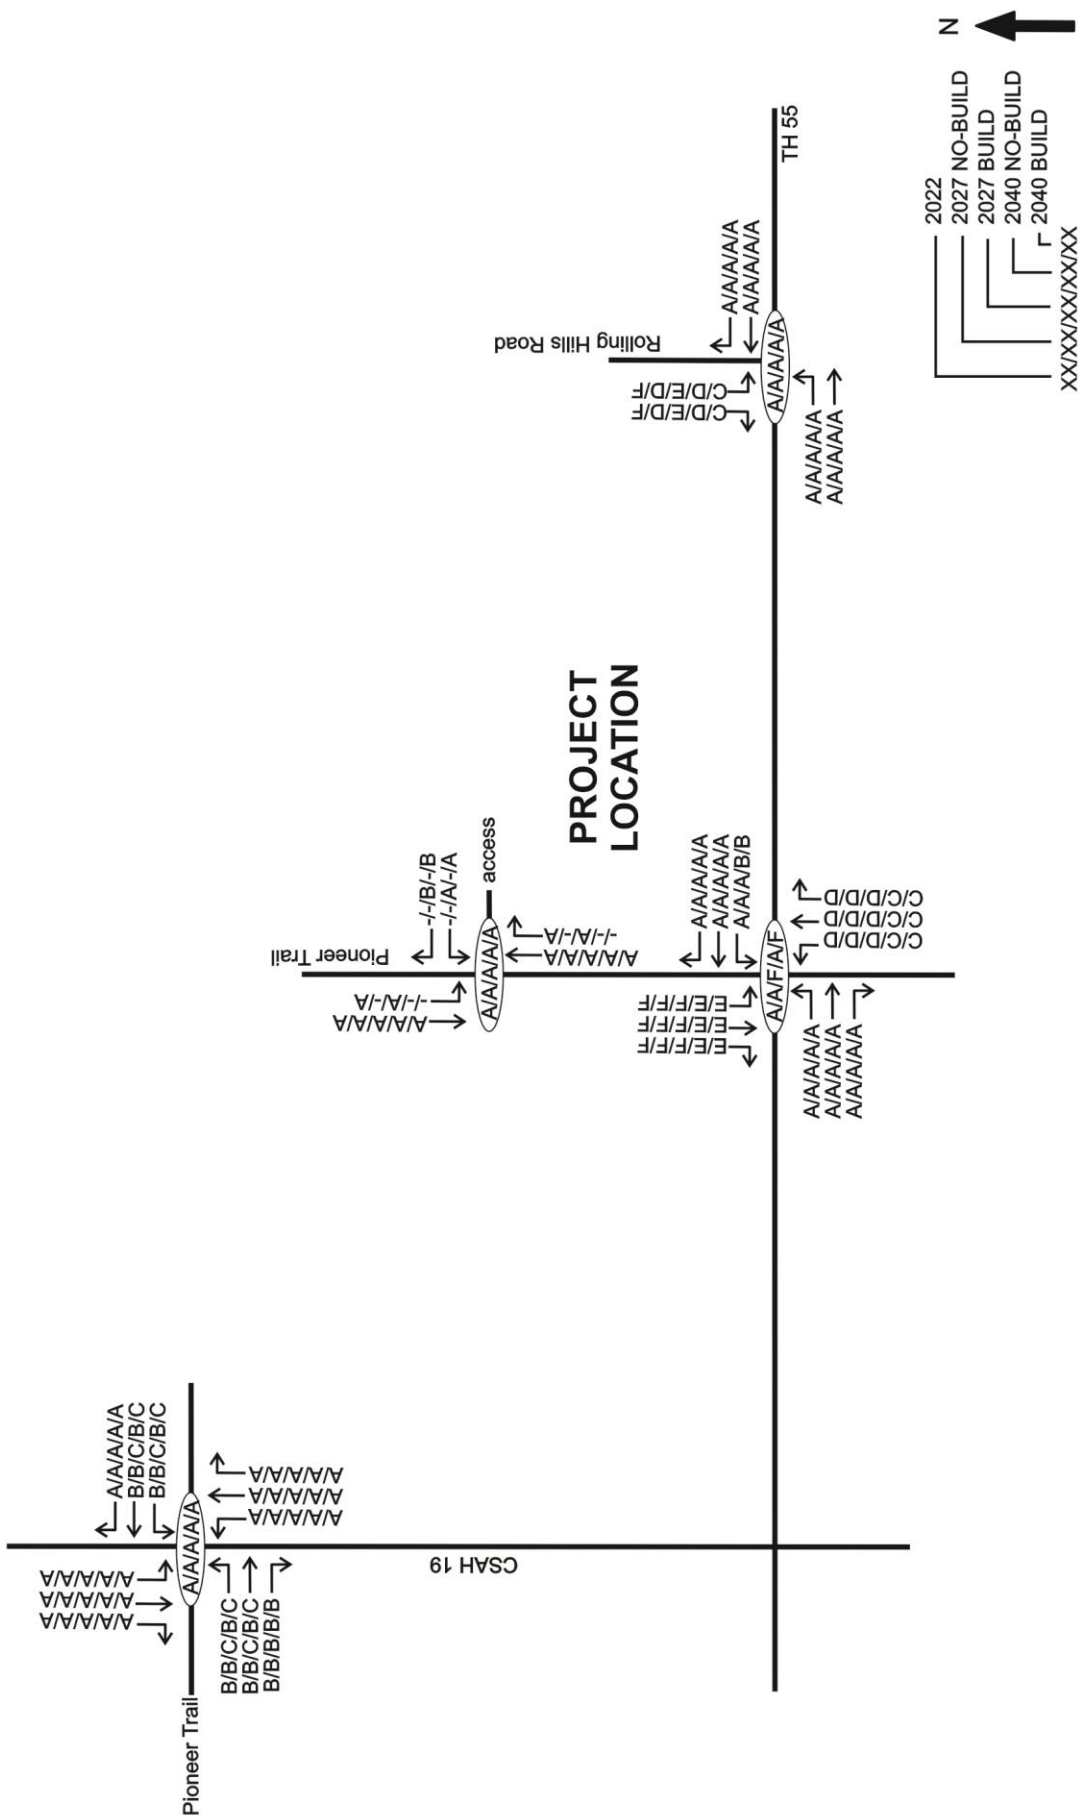
**FIGURE 6**  
**WEEKDAY AM PEAK HOUR**  
**LOS RESULTS**

- TH 55/Pioneer Trail
  - Short term – Widen southbound approach to accommodate a dedicated left turn lane and a through/right turn lane. Install traffic signal control.
  - Long term – No additional improvements needed.
- TH 55/Rolling Hills Road
  - Short term – No improvements needed.
  - Long term – No improvements needed.
- CSAH 19/Pioneer Trail
  - Short term – No improvements needed.
  - Long term – No improvements needed.
- Pioneer Trail/development access
  - Short term – Construct westbound approach with dedicated left and right turn lanes. Construct a northbound right turn lane.
  - Long term – No additional improvements needed.
